**THE OWNERS OF STRATA PLAN NO 61139
9-15 CENTRAL AVENUE, MANLY NSW 2095**

**MINUTES OF THE STRATA COMMITTEE MEETING OF THE OWNERS OF STRATA PLAN NO.
61139 HELD ON MONDAY 18TH OCTOBER, 2021 IN THE UPPER LEVEL CAR PARK,
9-15 CENTRAL AVENUE, MANLY AT 5.00PM.**

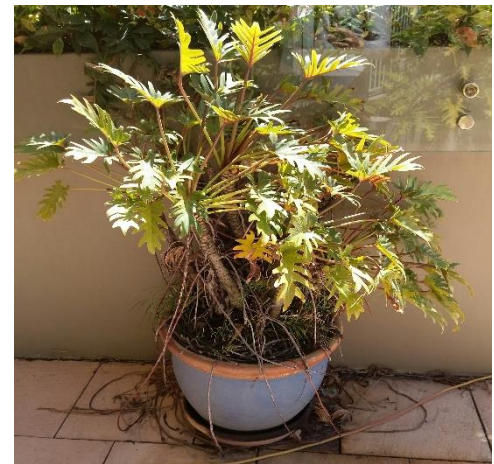
1.7 Root bound plant on level 2 pool area (FYI):

The root bound pot plant on level 2 by the pool toilets has been removed and disposed of. This pot plant had exceeded its useful life span and was a burden for the OCs gardener who was continuously pruning its root system.

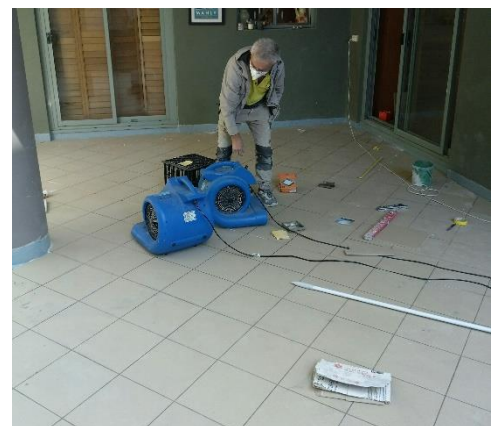
1.8 Unit 210 terrace re-waterproof and re tile work (FYI):

SC Members are aware that the unit 210 balcony terrace waterproofing and tiling system had come to the end of its service life. This balcony tiling system failed prematurely as a result of poor installation at the time of construction.

Inadequate drainage, poor falls in the contours of the tile work (resulting in constant water pooling) together with failed waterproofing all led to water ingress into the concrete slab which resulted in water leakage to the car park below.

The “summary of costs” below shows the money spent on this 100m2 balcony. The Works were carried out on a “do and charge” basis hiring trusted and skilled tradespeople under the supervision of the experienced BM.

The works will be completed this week and cost the OC around \$50k or around \$500 per square meter. **Important Note** – The OC paid approx. >\$1,000 per square meter to repair balconies 229 and 221 in recent years. The works at 210 will cost approx... \$500 per square meter. This “do and charge” method provide substantial savings to the OC.

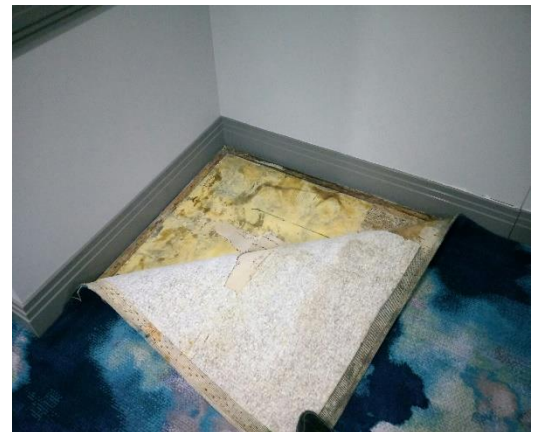
1.10 Level 7 shower leak (FYI):

The shower in the main bathroom of unit 705 developed a leak through the shower tray as a result of failed water proofing. This was discovered because the common area carpet opposite U703 was becoming damp for no apparent reason.

Regrettably this type of fault will happen more often as all showers in the building become subject to deteriorating membranes.

I have had the shower tray repaired by a local company “Shower Repairs” for \$785. Interestingly this same issue occurred in the other U705 shower only about 6 months ago, on that occasion the leak migrated to the inside of the apartment, not the common area.

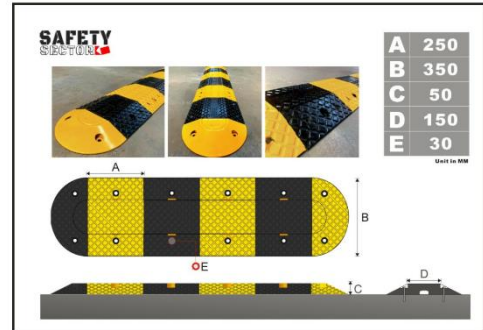
The speed hump at the bottom of the car park ramp also doubles as a water stopper device for the car wash bay. The speed hump is old and broken, its fastening bolts are rusted through and the silicone sealant beneath it has failed.

To replace the speed hump in the same style that it is in now will cost approx. \$1,000 and it will likely last the same length of time as the existing speed hump.

Alternatively for approx. \$3,800 a concrete speed hump could be installed. This would involve mechanical keying to the existing substrate, concrete saw cut and a small amount of jack hammer work. The result would be permanent and would never leak.

Recommendation: that the SC resolve to replace the speed hump to the current standard understanding that may fail and allow water to seep through in several years from now.

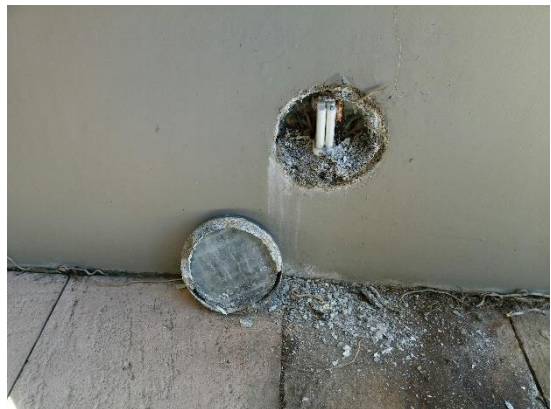
2.7 Lights in pool court yard area require replacing (SCDR):

Many of the lower lights in the pool courtyard area are unserviceable and cannot be repaired.

The internal body of the light fitting is almost non-existent, it has corroded away many years ago as a result of consistent water ingress from the planter boxes behind them.

Options include, complete removal of light and render the wall closed or partially render the wall closed and install an external light such as the round light shown on the right.

Recommendation: that the SC resolve to have these lights removed permanently and wall rendered closed noting that there is adequate external garden lighting already in use.
